# FLYING LESSONS for September 23, 2021

## ***This week's LESSONS:***

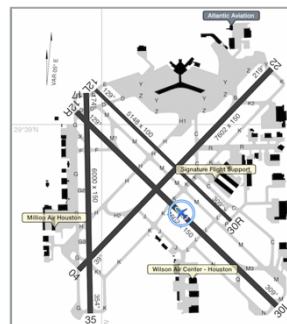
**Another great technology** that still presents a distraction hazard is the georeferenced taxi diagram. A GPS-driven symbol representing your airplane is overlaid on an airport diagram for instant orientation and easy planning your route between the ramp and the runway (or vice versa). It's especially helpful on airports with complex taxiway systems.

**The down side** is that these devices do not depict other airplanes or objects on the taxi, and may not have the fidelity to keep you from taxiing off the pavement.
